Homeland Inspection Services Inc.
7746 Park Ridge Circle
Fort Collins , CO 80528
(970) 567-7393 Fax (970) 207-1152

Report #: Sample

1100 Pennsylvania Ave

Loveland CO

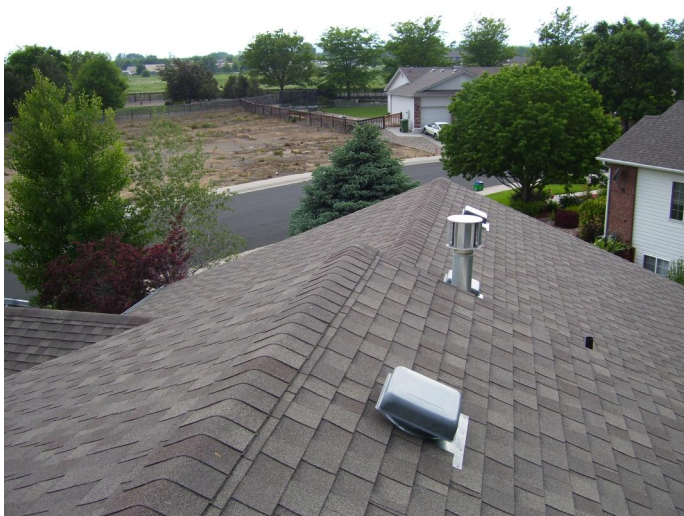
No missing shingles at this time

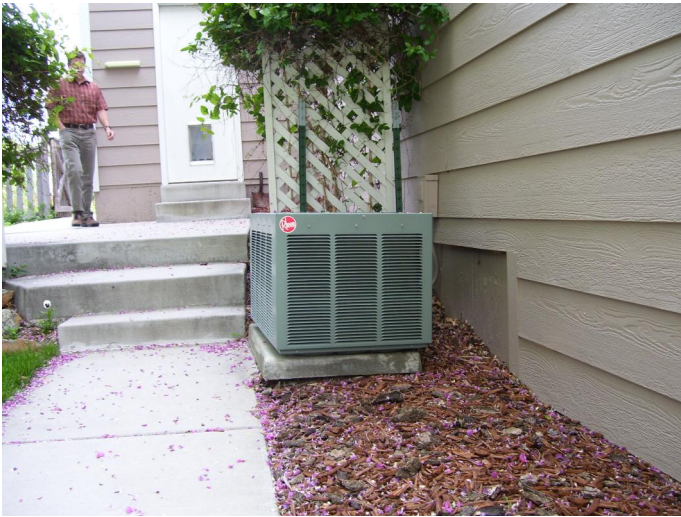
Monitor this east side A/C compressor for further settling.

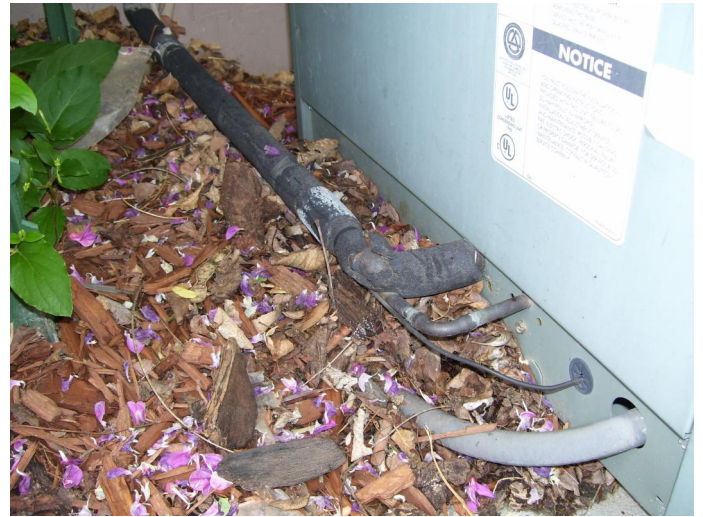
Comments: The insulation on the refrigerant lines is damaged. Replace with new foam rubber insulation to prevent icing(2)

Repair the damaged A/C line insulation at the exterior unit.

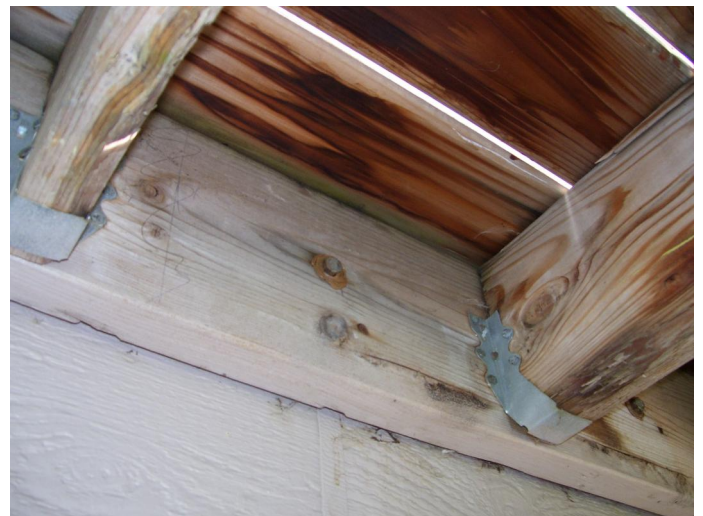
Comments: Flashings are not visible where the structure attaches to the building. (2) (3) Repair moisture damaged portions of the rear exterior door frame and trim on the deck.(2)

Install proper flashing at the deck ledger/wall interface to prevent moisture damage.

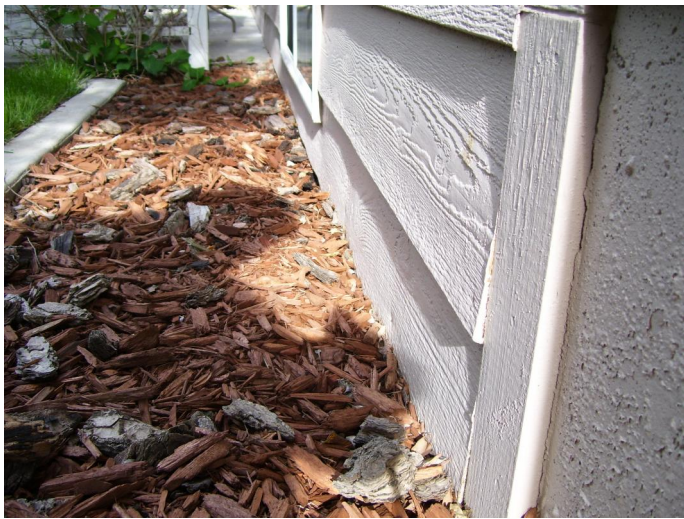
Comments: Have a qualified siding contractor replace the moisture damaged, wet bottom course of siding at the rear garden level.
 (2) High moisture levels were detected inside the basement at the wood sill plate. Recommend further evaluation and repairs by a qualified professional. (2) Remove mulch and/or soil in contact with any siding.(2)

Replace the moisture damaged bottom course of masonite siding at the north exterior.

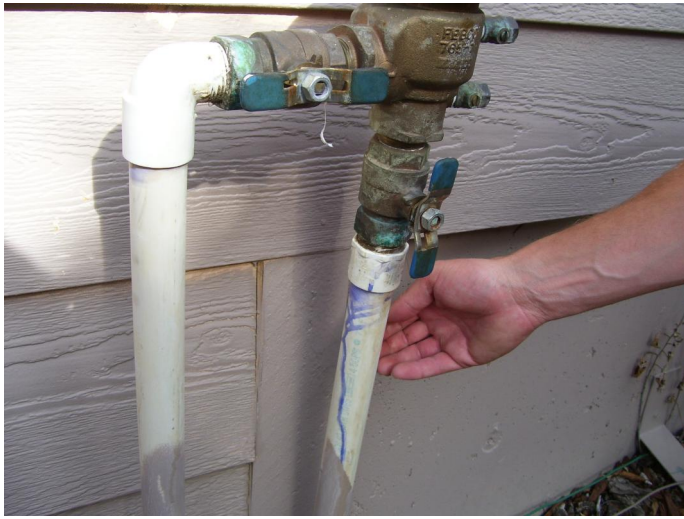
Comments: This company does not inspect sprinkler systems. Repair the leaking sprinkler backflow device at the west exterior.
 (2)

Repair the active leak at the exterior sprinkler backflow device

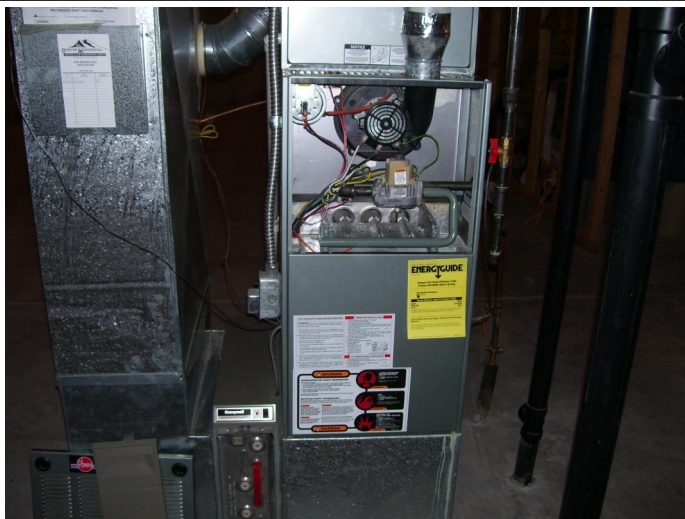
The furnace appears serviceable at this time

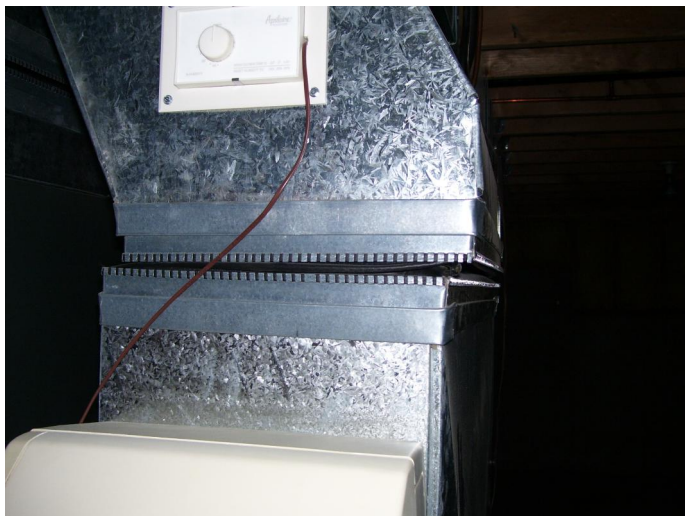
Comments: Have a qualified HVAC contractor further evaluate and repair the lack of a flexible boot in the vertical return air trunk line in the basement. There is no room for slab expansion.(2) The distribution system appears to be in serviceable condition.

Install an expandable boot in this basement furnace truck line per current standards.

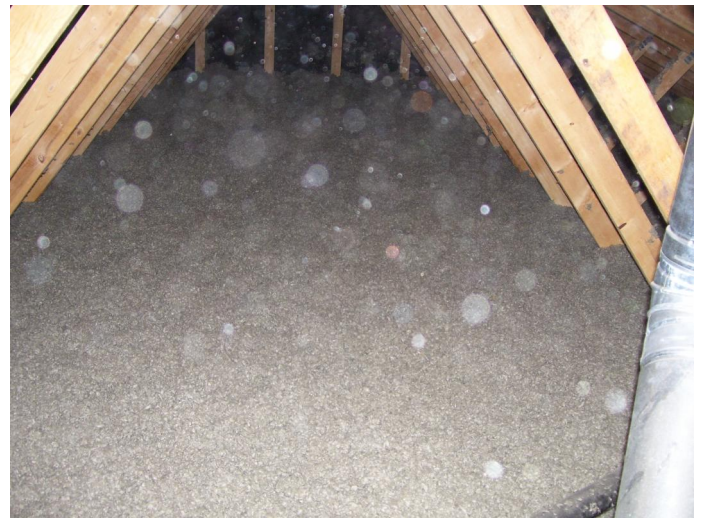
Well insulated attic space
